Service Bulletin

Subject: Ram HD transmission issue

Applicable Models: 2013-2016 Ram HD's equipped with 6.7L Cummins and 68RFE automatic transmission

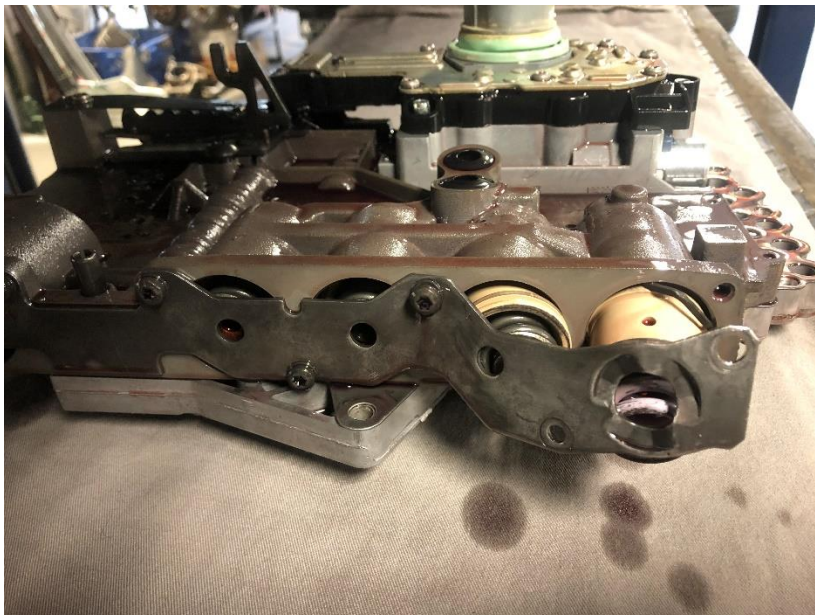
Condition: Transmission can shift in and out of gear, finally going to Neutral. After a key cycle, the transmission will be in limp mode. Possible codes setting can be P0734, or 0735 (incorrect gear ratio in 4th or 5th, respectively)

Diag/Repairs: There is a plate in the valve body that holds several valves in place, see the photo below. Bolts holding this plate in place can loosen up over time and allow the valves to push the plate out, resulting in loss of holding power to the clutches and the transmission going into limp mode. To fix, the valve body can simply be replaced. However, it is not uncommon for dealers to attempt to replace or rebuild the entire transmission assembly. Prior to a failure there is little preventative maintenance that can be performed other than removing the transmission pan to inspect the bolts in question. Later year trucks had Loctite applied to these bolts from the factory, but 2013-2016 trucks can still be affected.
