## Service Bulletin

**Subject:** Orange light on ProCal Snap with harness installed

**Applicable Models:** 2019+ Ram HD trucks using the AEV ProCal Snap

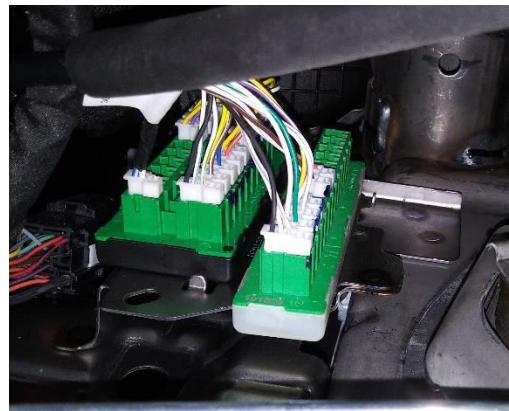
**Condition:** Orange light on with harness plugged in and ignition in RUN, possible odd behavior from vehicle such as auto steps not working

**Diag/Repairs:** Certain trim levels of Rams have more than one green Star connector. If this is the case, one will have a single row of plugs while the other will have two rows; the harness needs to be plugged into the two-row connector as shown.
